**Type A Accident  
Investigation Board Report  
of the February 13, 1997  
Welding/Cutting Fatality  
at the  
K-33 Building, K-25 Site  
Oak Ridge, Tennessee**

## **1.0 INTRODUCTION**

### **1.1 BACKGROUND**

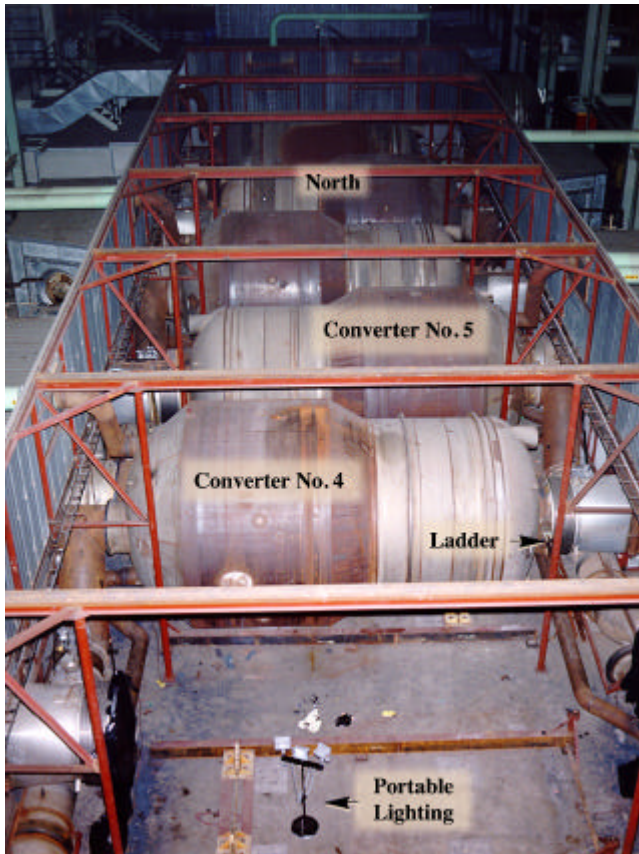
**Exhibit 1-1. View Looking North in Cell 7,  
K-33 Building**

The basic equipment unit in a gaseous diffusion plant, referred to as a stage, has three main components: an electric-motor-driven compressor, a converter containing a very large surface area of semi-permeable barrier material, and the process gas heat exchanger. A grouping of stages is referred to as a cell. The related piping systems connect eight equal-size stages to form a cell, which is enclosed in sheet metal. K-33 contains 640 stages grouped into 80 cells. The cells are grouped into units, and the units constitute a cascade. Exhibit 1-1 shows several of the remaining six stages comprising Cell 7 of K-33 at the time of the accident.

The scene of the accident was within Cell 7 of the K-33 Building (see Exhibit 1-1). A planning meeting for the removal of three "000" converters from K-33, Unit 8, Cell 7 was held on January 27, 1997 (four days after the Safety Work Permit was issued), and a subsequent Maintenance Job Request was issued on January 27, 1997. The cell roof, two converters, a small side panel on the east wall adjacent to Converter 3, and a small side panel on the west side adjacent to Converter 5 had already been removed from Cell 7 at the time of the accident. As a result of the work done in 1996 at K-31 [referred to as the Small-Scale Metal Recycle Project (SSMRP)], plus earlier extensive equipment replacement activities during operations prior to 1985, LMES had classified the removal

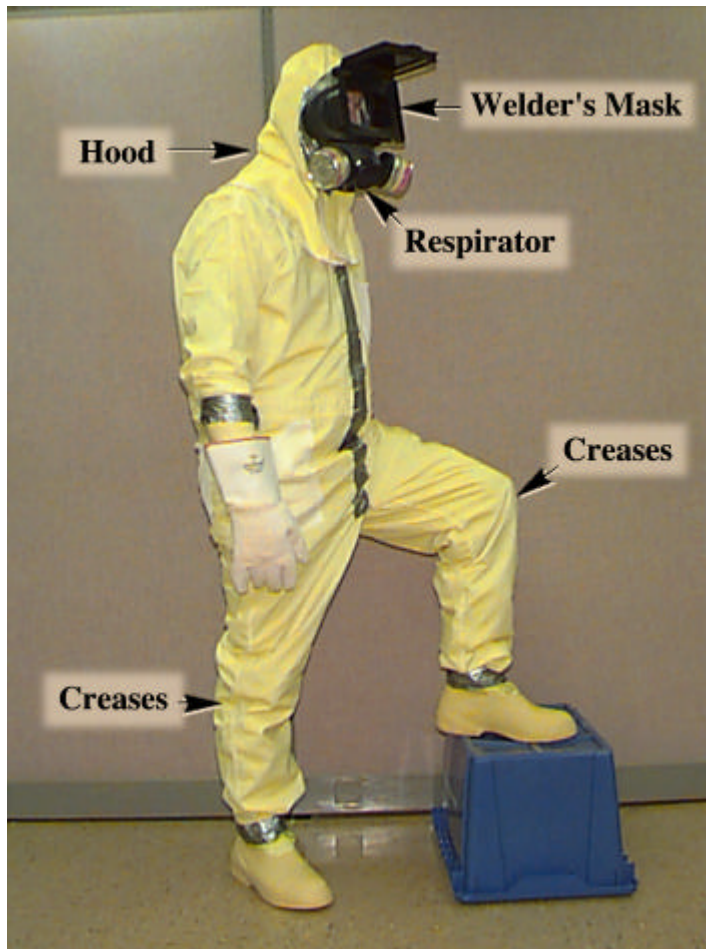
#### **Exhibit 2-1. Similarly Outfitted Welder**

At the time of the accident, the Welder was wearing one set of underwear, one set of 100 percent cotton blue general-purpose coveralls, two sets of 100 percent cotton yellow anti-contamination coveralls, one pair of cotton liner gloves, one pair

of latex gloves, one pair of terry cloth welder gloves, one pair of safety shoes, one pair of plastic booties, two pairs of plastic shoe

covers (scuffs), one pair of rubber totes, a skull cap, a hood, a full-face respirator, a personal air monitor, and a welding mask clipped to the respirator. Exhibit 2-1 shows a similarly outfitted welder.

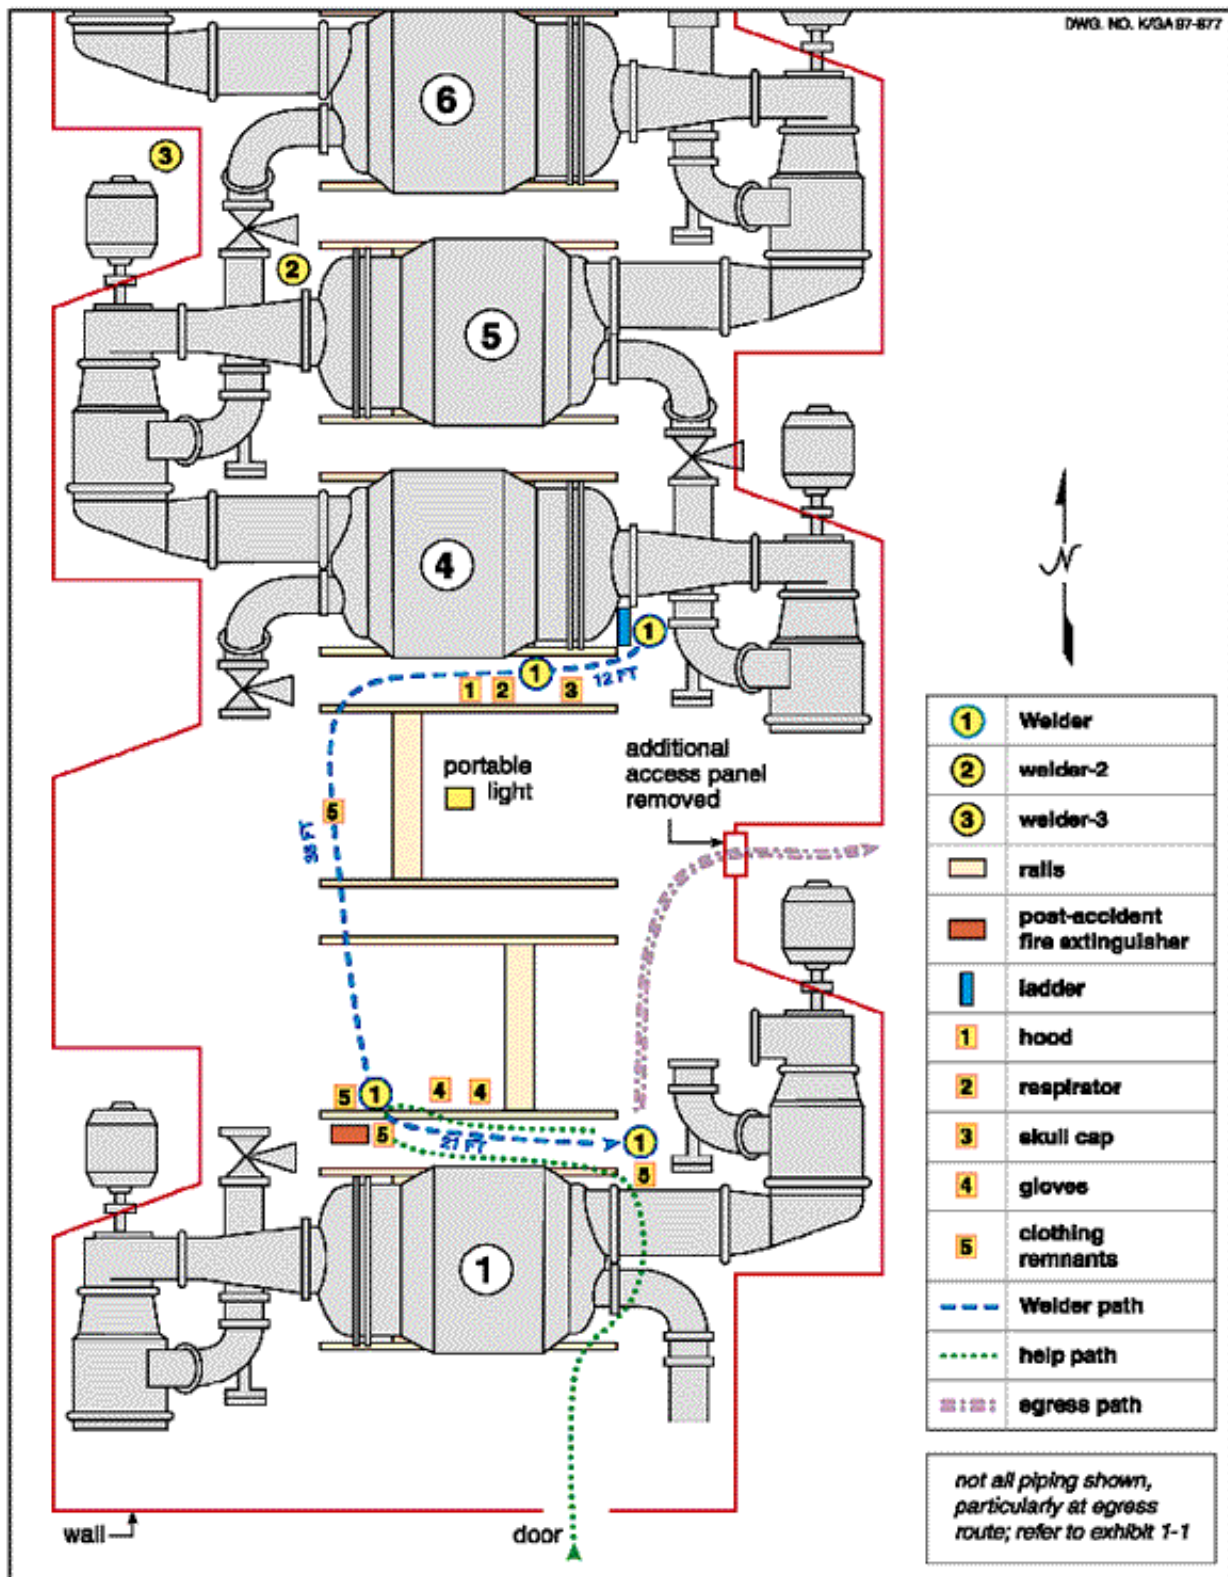
Figure 2-1. The Welder's Location and Movement Within Cell No. 7

eyewitnesses. The Board has reconstructed the most probable sequence of events (through extinguishing the flames by a maintenance mechanic), using the physical evidence, interviews, and results of burn tests. A schematic of the inside of Cell 7, the relative location of personnel, and the path of the Welder after he became engulfed in flames is shown in Figure 2-1. At approximately 11:09 a.m., a piece of hot slag or a spark ignited the Welder's anti-contamination coveralls at or somewhat below his left knee. At approximately 11:10 a.m., the Welder felt heat and noticed that the clothing on his left leg was on fire. The Welder attempted to put out the flames while he was still on the ladder. He came down the ladder, moved to the south side of Converter 4, and screamed for help while still trying to put out the flames. He removed his mask and respirator and screamed for help again. Because the respirator muffled the first scream, only the second scream was recognized as a distress call by one of the four maintenance mechanics outside Cell 7.

*The Welder's outer coveralls ignited, but he did not know it for perhaps a minute or more. His first call for help was muffled by his respirator.*

Two maintenance mechanics requested permission from a radiological control technician to enter Cell 7. One of them turned off the oxygen and acetylene cylinders of the Welder's torch, located outside Cell 7, while the other entered Cell 7, crawled under the piping, and saw the Welder, who was now standing on the cell floor northwest of Converter 1, totally engulfed in flames. While attempting to help the Welder remove his burning clothes, the maintenance mechanic's gloves caught on fire, so he stepped back and extinguished his own gloves by rubbing them together. At this point, the Welder began to run in a path that took him to the northeast side of Converter 1, where he fell to his knees on the floor of the cell (see Figure 2-1). The maintenance mechanic picked up a dry-chemical fire extinguisher and extinguished the flames at approximately 11:12 a.m.
